Franklin Village

The Challenge

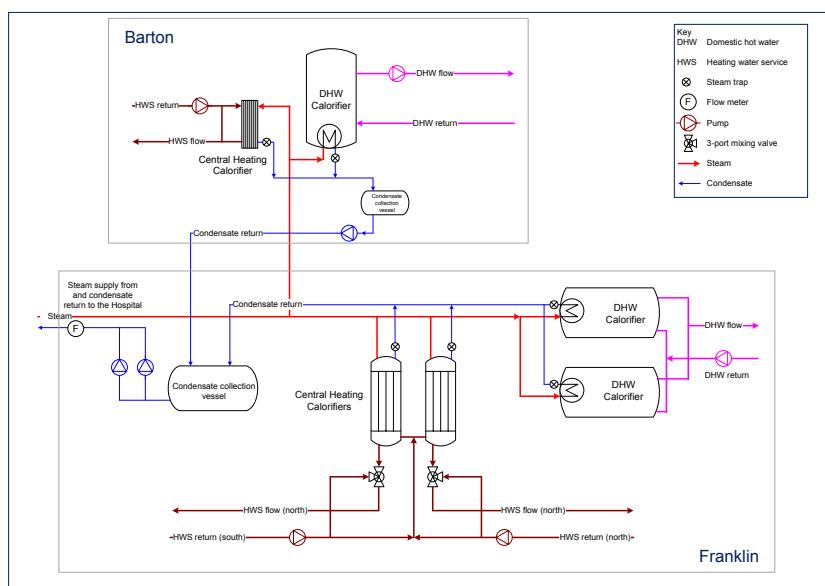
Bryn Martin carried out an energy audit. It started by understanding the intent and function of the existing steam and heating systems. One of the first outputs was a schematic diagram of the steam system.

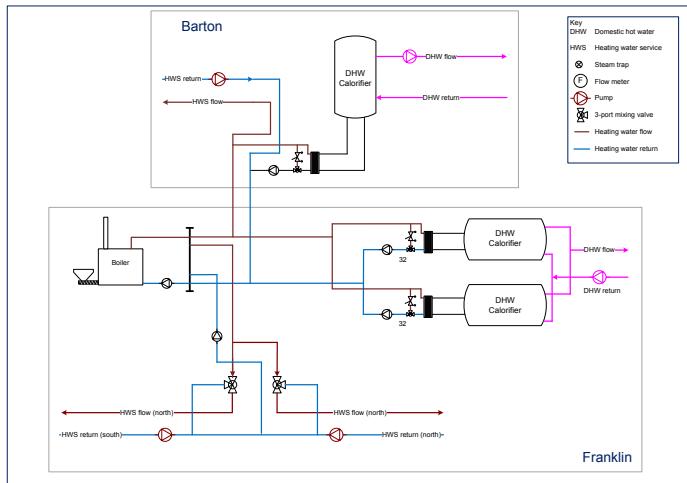
The first, before any significant investment was made in the existing steam system, was that the Customer should establish the security of the long term supply of steam from the Hospital. If it was not secure, the consequence would be the need to become self sufficient in energy. Bryn Martin provided advice and estimated capital and operating costs of what such plant might be. One possible plant configuration is reproduced to the left.
